**N18 Ennis Bypass  
and  
N85 Western Relief Road  
Clare Abbey, Co. Clare**

**Final Archaeological Excavation Report  
for  
Clare County Council**

**National Monument Consent: C020**

**Record Number: E2021**

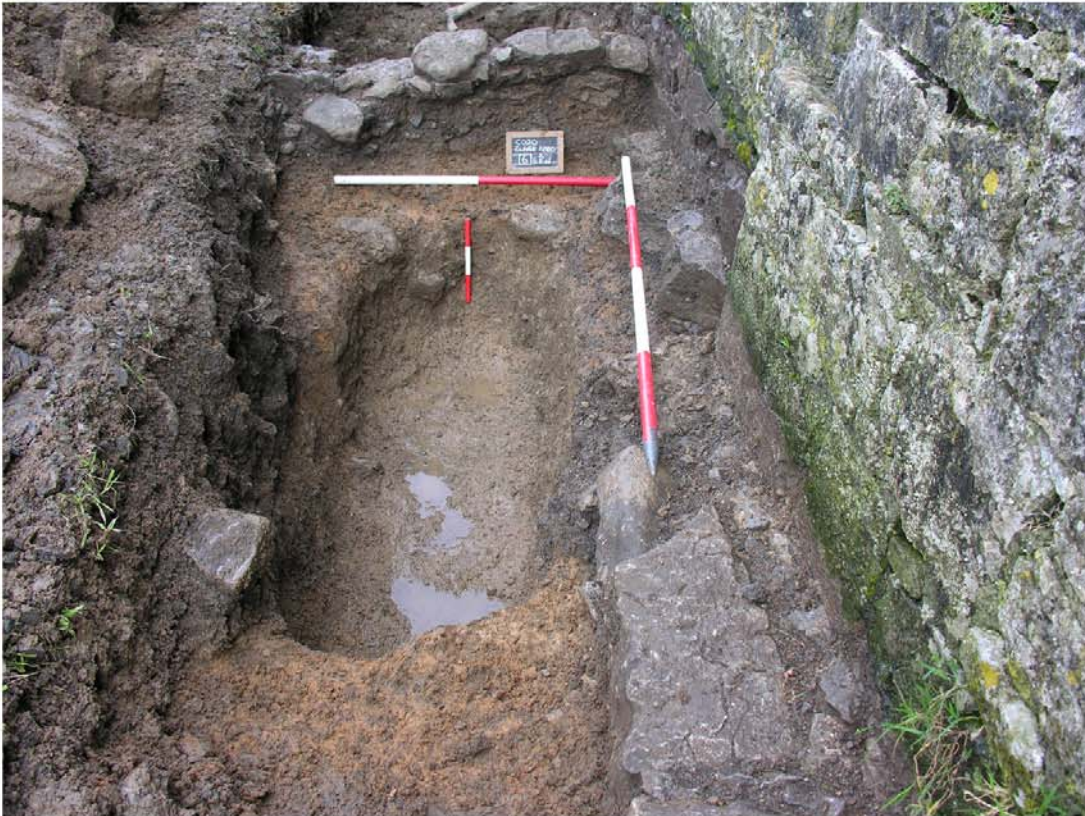
**Plate 9: Pit 6. Looking north. Scales 2m, 1m and 0.3m**

The earliest activity recorded on the site was the excavation of two large pits, 6 and 45, (Figs 9, 10 and 14, Plates 9 and 10). Pit 45 stratigraphically pre-dated Pit 6. Pit 45 was somewhat amorphous, measured 1.85m by 1.60m and was 0.35m deep. Pit 6 was a rounded rectangle in plan and was very precisely cut. The feature measured 2.1m by 0.7m-0.8m and was 0.6m deep. The fill of Pit 6 has been radiocarbon dated to AD 1030-1220 (Beta-231531) and could predate or be contemporary with the construction of the abbey that presumably began soon after the claimed foundation date of AD 1189 (see historical background above). The foundation wall 124 seems to respect the edge of pit 6. It is possible that pit 6 disturbed the wall but equally possible that wall 124 avoided pit 6.

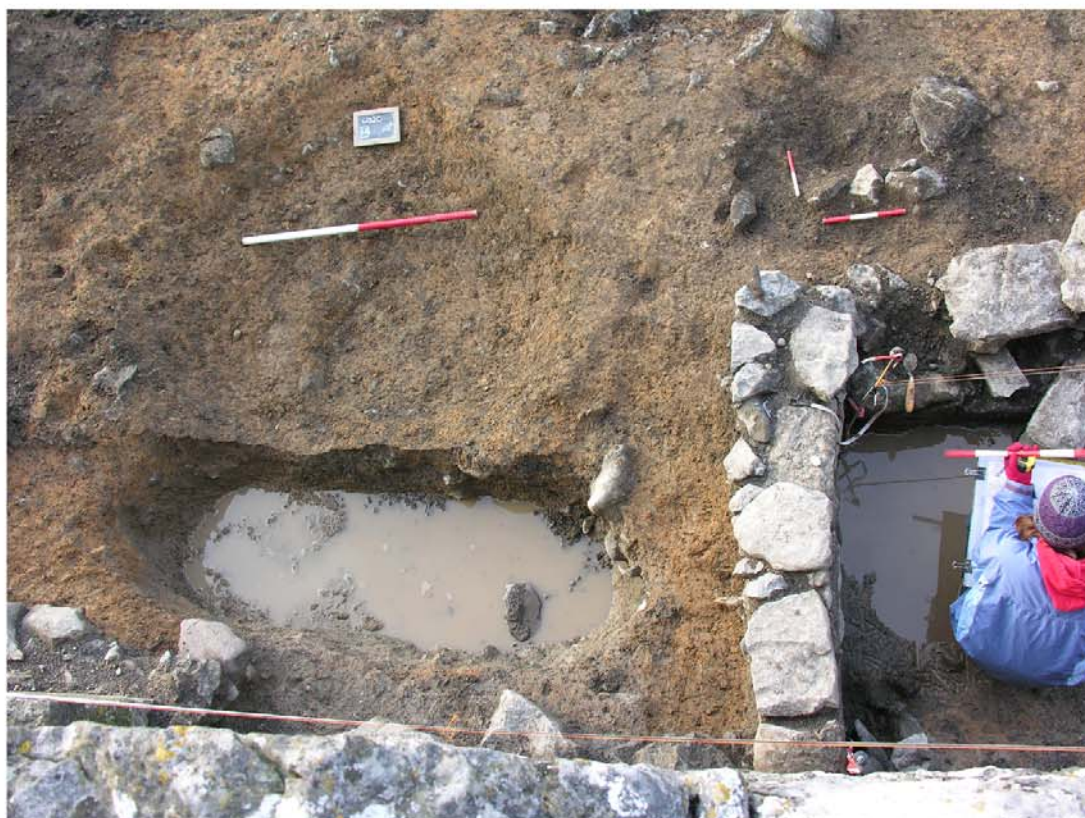
**Plate 10: Pits 6, 45 and cess pit walls 4 and 36. Looking west, scales 1m, 0.3m and 0.2m**

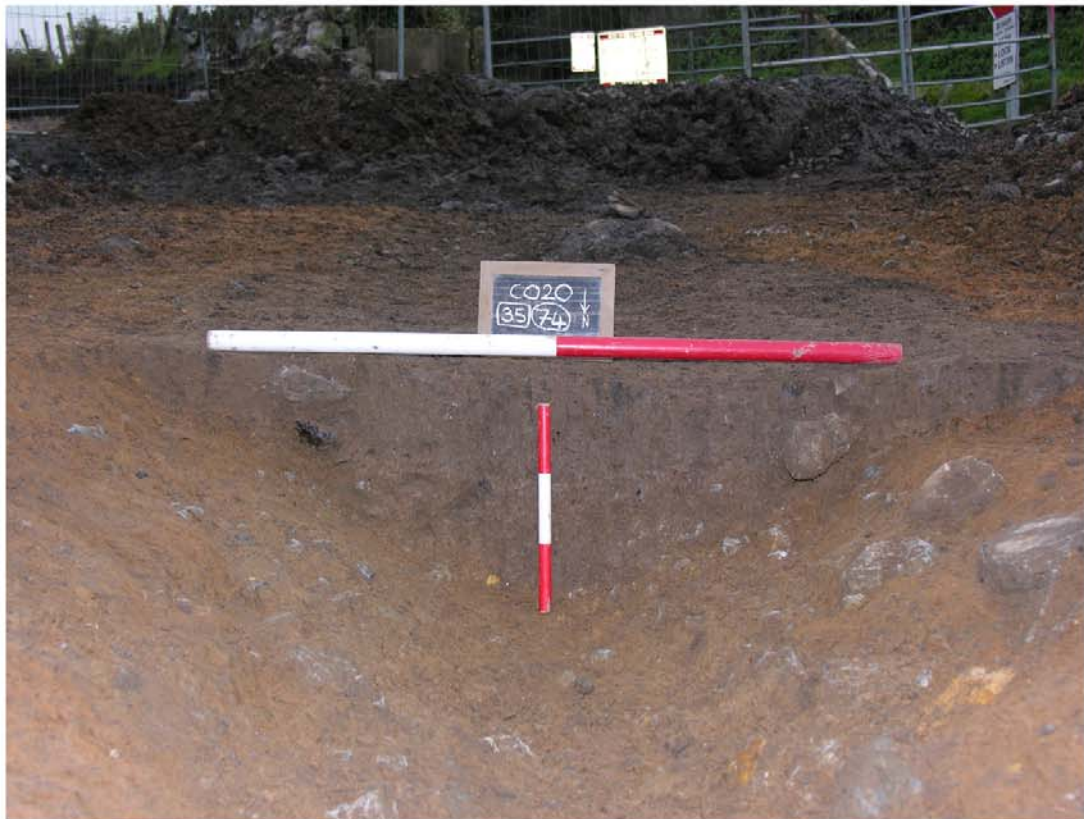
**Plate 19: Ditch 35. Looking south. Scales 1m and 0.3m**

Two parallel gullies (or ditches), 3 and 35, were excavated in the centre of the site (Figs 8 and 11, Plates 14-19). These features were orientated from north-north-east to south-south-west and were typically 5m apart, parallel to the west wall of the abbey. Ditch 35 cut the similarly aligned feature 123. Also on the same alignment as the ditches, was a series of four postholes (38, 40, 41, 42) (Figs 8, 9, 10 and 11, Plate 21). Relative to the intensity of archaeology found on the rest of the site, the space between the linear features 3 and 35/123 was largely devoid of archaeological features (Fig. 8). It is possible that modern truncation had destroyed deposits here, but it is also noteworthy that this area corresponds with a trackway shown on the 1840 Ordnance Survey Map (Fig. 6). If these gullies are associated with the trackway, then they may have served to drain the track in a wet area.

The fill of ditch 35 returned a radiocarbon date of AD 1220-1310 and 1360-1380 (Beta-231533) and the fill of posthole 38 was radiocarbon dated to AD 1160-1290 (Beta-237218). Assuming that ditch 35 and posthole 38 are contemporary, the radiocarbon date overlap would suggest that the features were in use in the period AD 1160-1220. These dates correspond well with the claimed evidence for the founding of the abbey in 1189 and suggest that a defined access route to the abbey was laid out at the time of the abbey's construction.

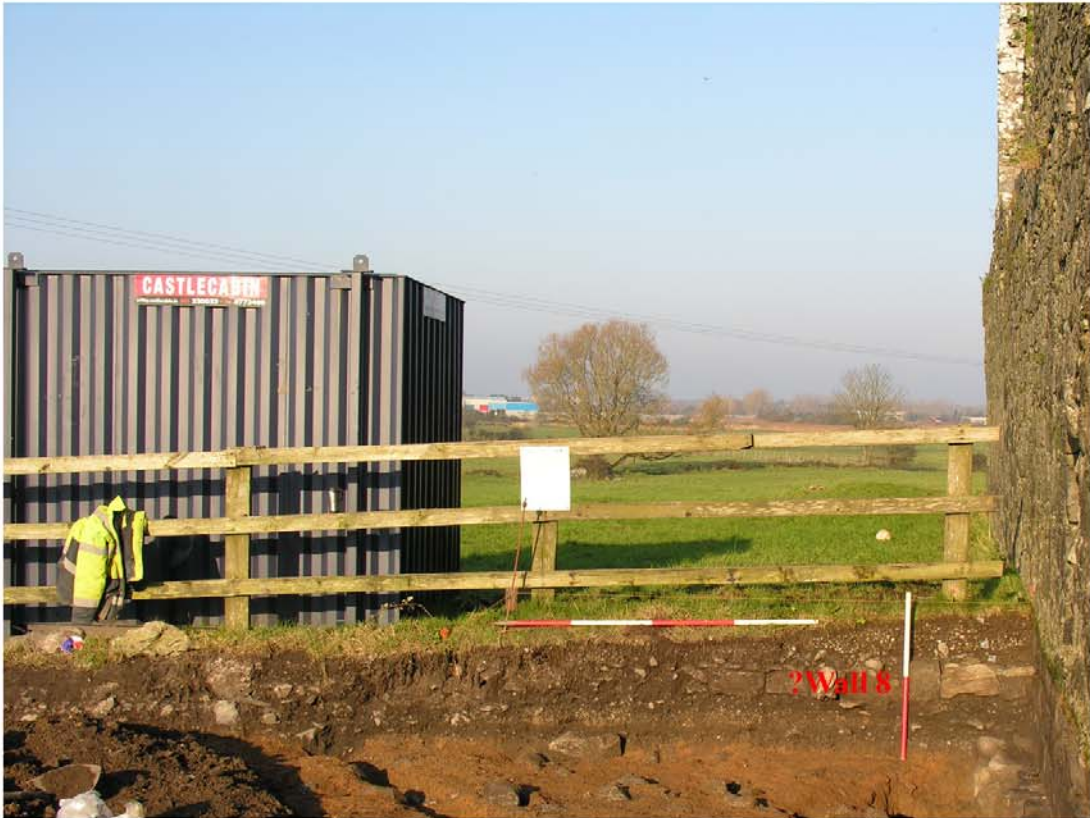
**Plate 23: South-facing section showing Tumble 58 and possible Wall 8. Looking north. Scales 2m and 1m**

At the east of the site, close to the abbey west wall, the cess-pit and associated features and many of the Phases I and II features were sealed by a substantial layer of limestone rubble with sandstone roofing tile, 58 (Fig. 12, Plates 23 and 26). It is likely that deposit 58 represent collapse of part of the abbey west wall and also that the building adjacent was roofed. This building may have once been the abbey kitchen. The artefacts found in the collapse (tumble) 58 were generally post-medieval in date. It might be thought odd that artefacts were found in collapsed wall material and there may therefore be a degree of intent in the deposit that could indicate deliberate destruction. No cut stones were found within the rubble and it is therefore likely, given that the cloister would have been vaulted and pillared, that these architectural parts had been robbed prior to the deposition of layer 58.

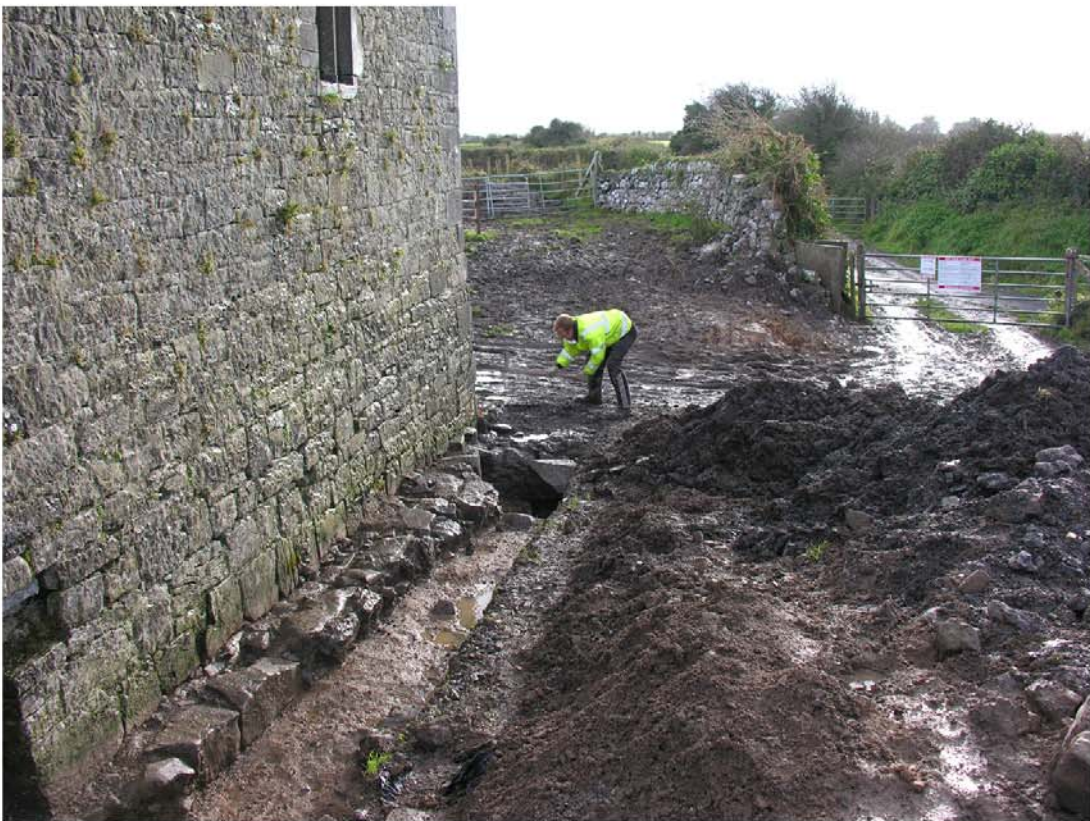
**Plate 24: Foundation stones 124. Looking south-east**

Beneath the abbey west wall (28) a single course of foundation stones, 7 and 124, was observed. (Figs 9 and 10, Plates 11 and 24). These stones rested directly onto the natural geology. There was a break in the foundation stones that corresponded with the location of the cess-pit (see below) and with pit 6 (Fig. 10) and it is possible that stones had been removed from the abbey foundations to allow insertion of these features. It is also very possible that there were two different builds in the abbey west wall, corresponding to the construction of the kitchen and the cloister (Plate 20). Both walls are undoubtedly medieval in date and the foundations at the north (cloister) were numbered 7 and the foundation stones at the south (kitchen) were numbered 124. There is a slight difference of orientation between the kitchen wall and the cloister wall (Fig. 9) and foundation 124 appears slightly wider than foundation 7. and with the visible break in the masonry, this suggests at least two separate construction phases.

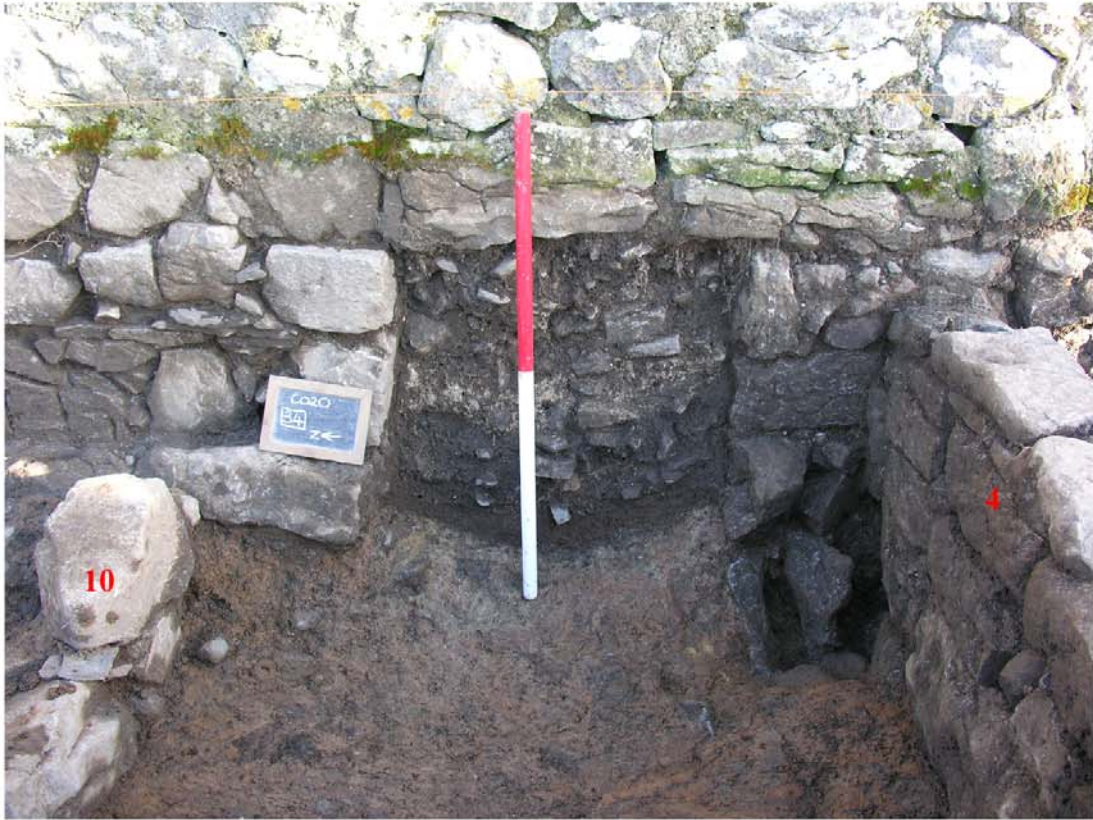
**Plate 25: Cut 34 in abbey west wall for cess egress. Looking east. Scale 1m**

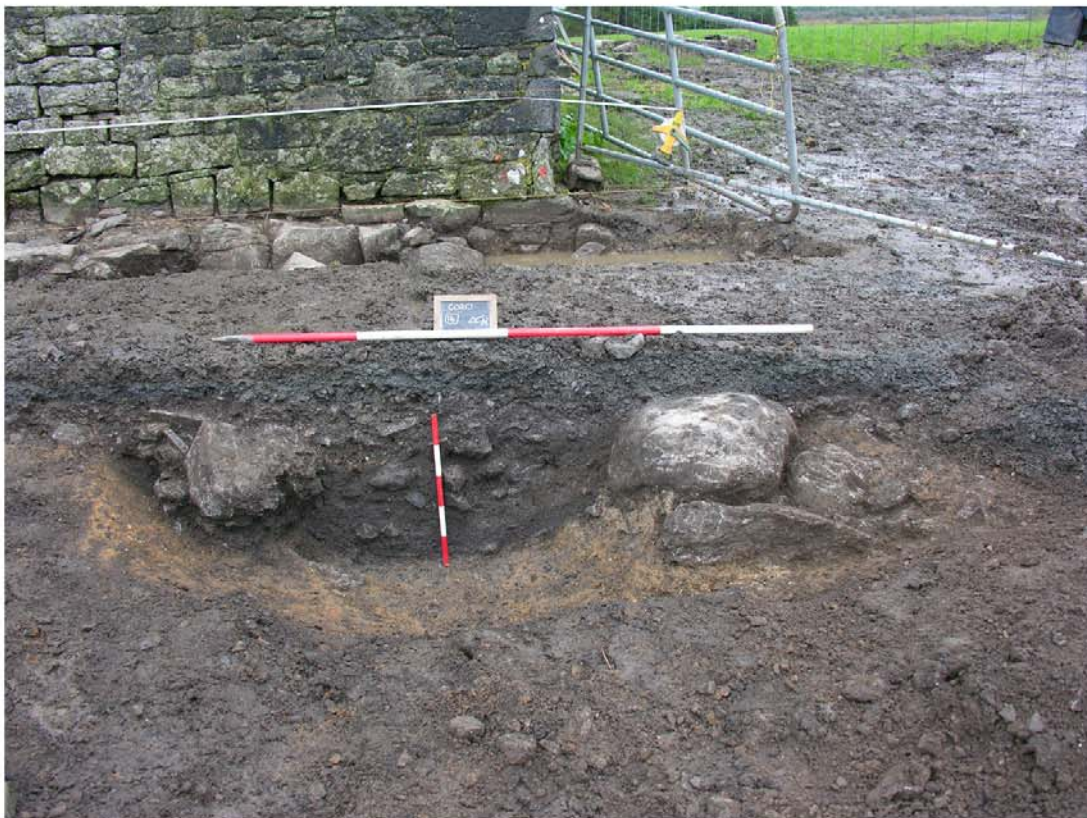
**Plate 28: Ditch 14. Looking east. Scales 2m and 0.5m**

Stratigraphically pre-dating the partial collapse of the abbey west wall, were wall 33 and the seemingly associated ditch 14 (Fig. 9, Plates 14, 27 and 28). These features post-dated the construction of the abbey west wall but were set at approximately right-angles to it, and these features may be the remains of a building appended to the abbey. It should also be considered that the collapse/tumble 58 may not relate to the abbey but represents this appended building. Wall 33 and ditch 14 did not disturb the foundations of the kitchen wall. The ditch was not dated although a piece of clay tobacco pipe from the 18<sup>th</sup> or 19<sup>th</sup> century was found in the upper fill.
