**N5 Longford Bypass
Stage 1 Test Trenching**

An Archaeological Assessment Report

08E0861

28th January 2009

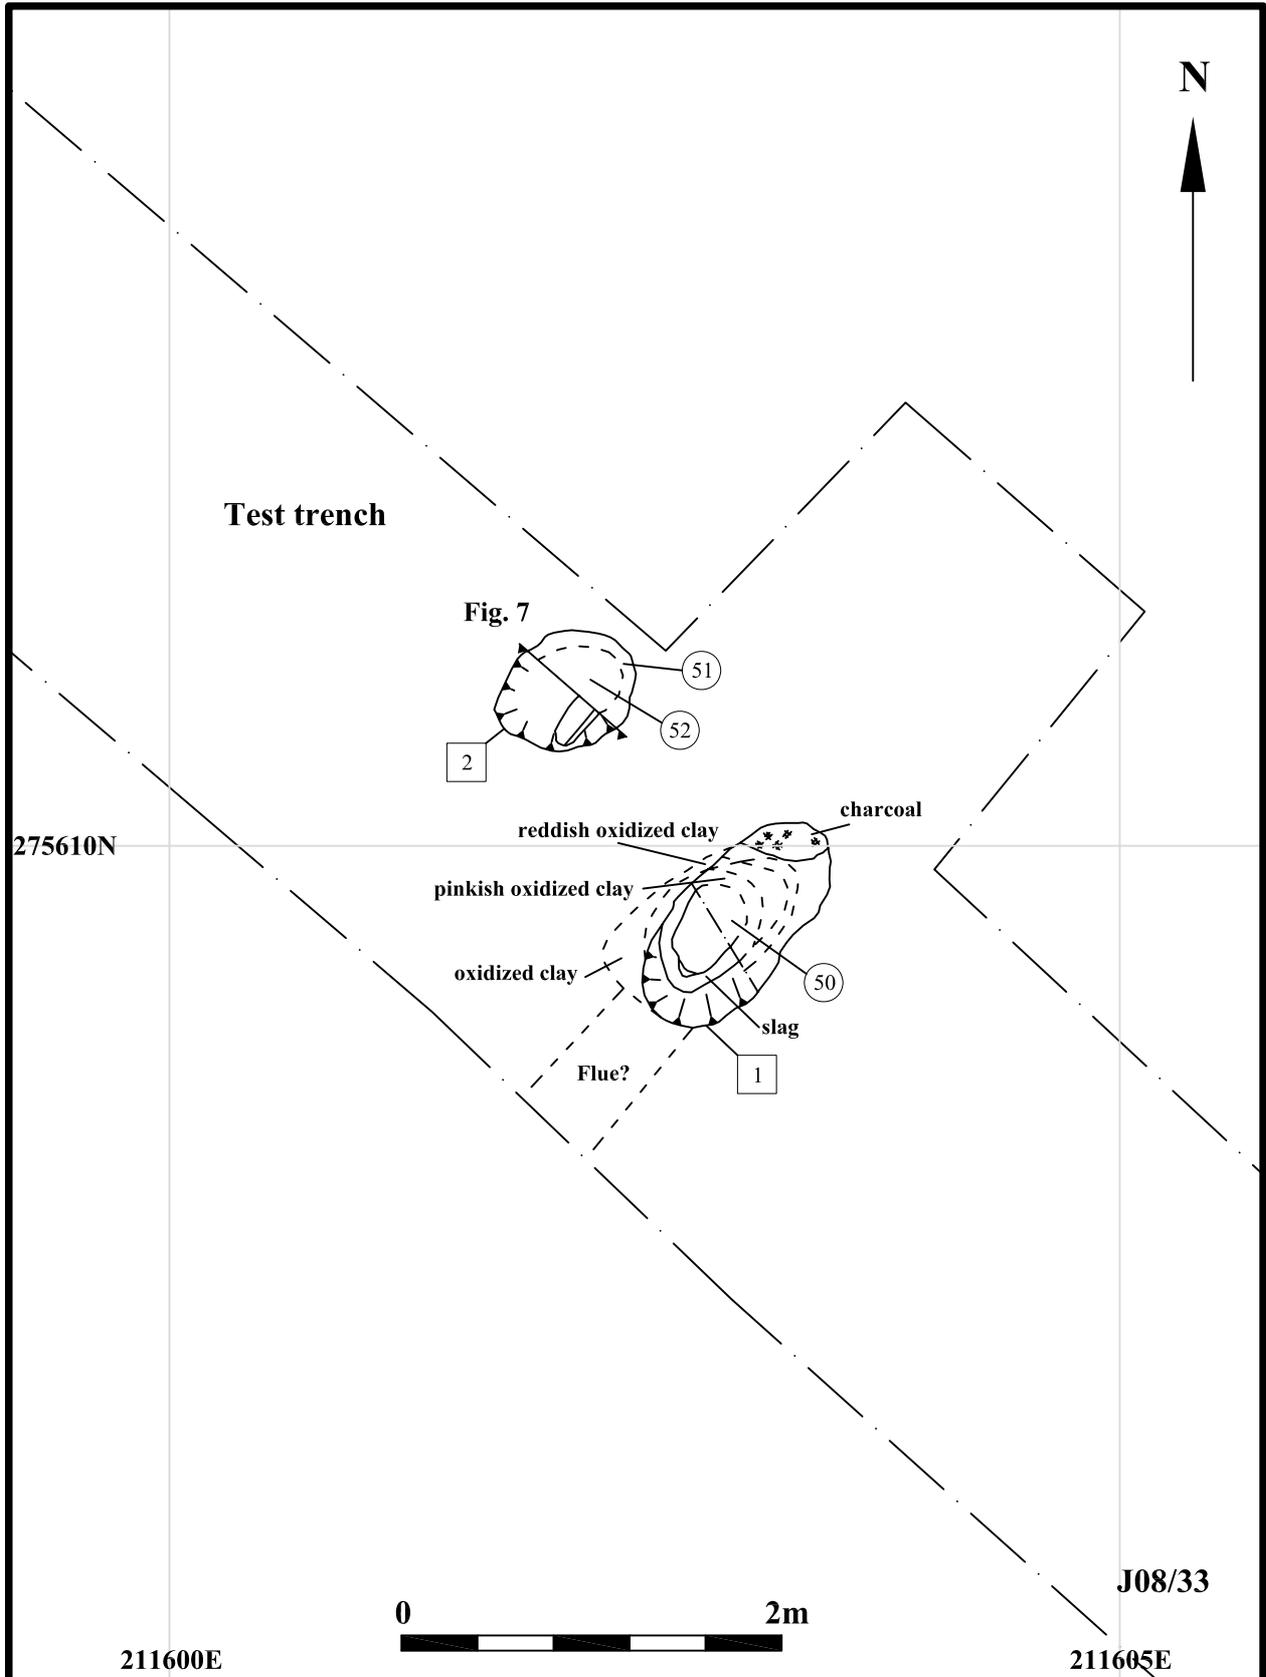
Figure 4: Plan of Pits 1 & 2

Feature 1 is oval in plan and measures 1.30m (south-west to north-east) by 0.64m. The feature was not fully excavated but is likely to be in excess of 0.2m deep. The feature is characterised by red oxidised clay and frequent charcoal inclusions within a dark brown silty matrix (50). Iron slag and fuel ash residues suggest that the feature is an iron smelting furnace.

Feature 2 lies 0.8m to the north-west and is a circular bowl-shaped pit. The feature was half-sectioned, has a diameter of 0.62m and is 0.17m deep. Two fills were noted (51 and 52). The primary fill 51 is a 0.05m thick, friable, greyish brown silty loam with charcoal flecking and includes occasional small pebbles. The secondary fill 52 is a 0.09m thick, friable orangish brown loam with large pieces of limestone inclusions.

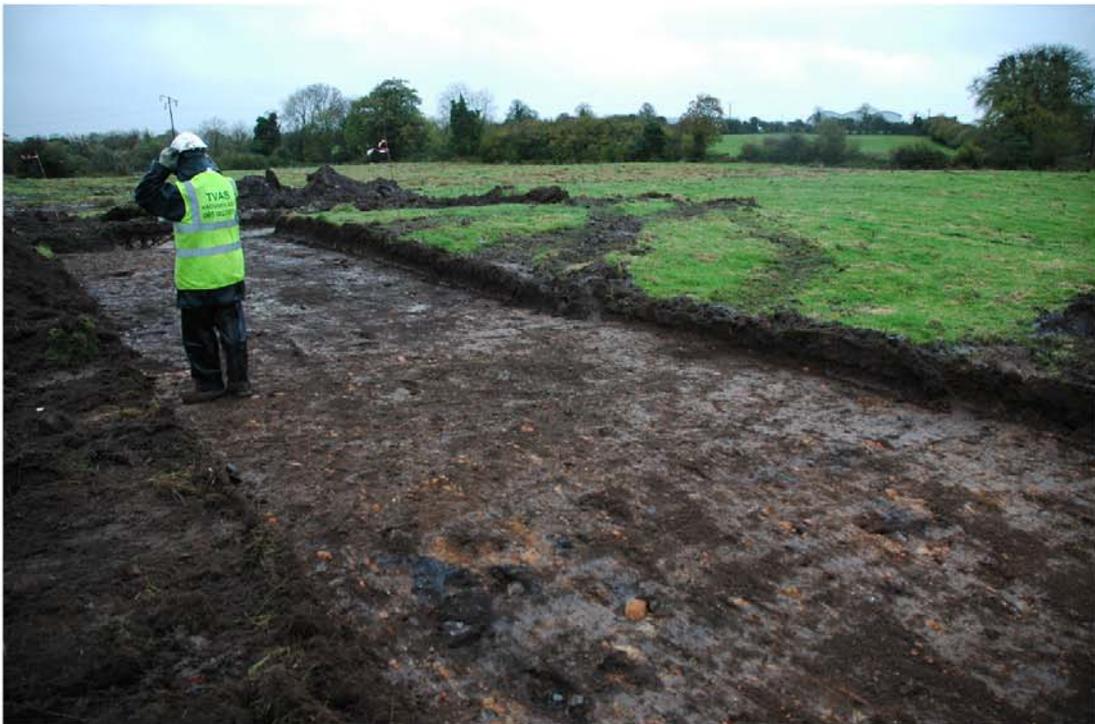
Plate 14: Field 8. Brick making kiln

The heavily disturbed remnants of a brick making kiln were found in Moneylagan townland, centred on NGR 212451 276818 (chainage 2090) (Fig. 2 and Plate 14). The plough-damaged parallel lines of brick and charcoal were observed on the surface of the naturally deposited clay beneath approximately 0.15-0.20m of topsoil/scraw. An open area of 110.71m² was stripped back around the brick deposits to reveal the full extent. The brick-rich deposits measure approximately 24m (south-west to north-east) by 13m and are one brick thick (approximately 0.08m).

Brick kilns (or clamps) are a relatively common feature of the later 18th and 19th century landscape, especially given the presence of fine clay and rapidly growing towns. The example found here to the west of Longford is undoubtedly of late 18th or earlier 19th century date.

Excavation is not proposed for the brick kiln in Field 8 due to its late date or, for similar reasons, the early modern pit in Field 22. No further work is recommended in the vicinity of the find of struck flint in Field 17 or for the dump of post-medieval pottery in Field 22.

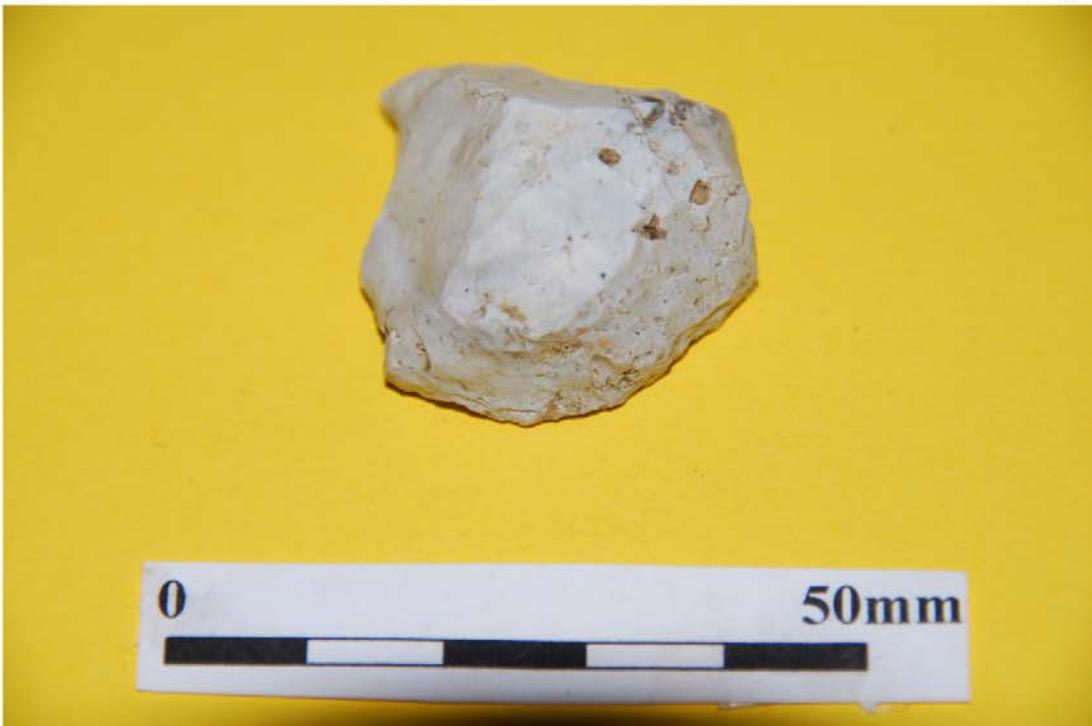
Plate 28: Burnt and struck flint. Topsoil Field 17

A single piece of struck and burnt flint was found in Cartrons (Longford) townland from the topsoil at NGR 211895 276008 (chainage 1100) (Fig. 3 and Plate 28). The piece measures 35mm by 30mm by 15mm and weighs 14 grammes.

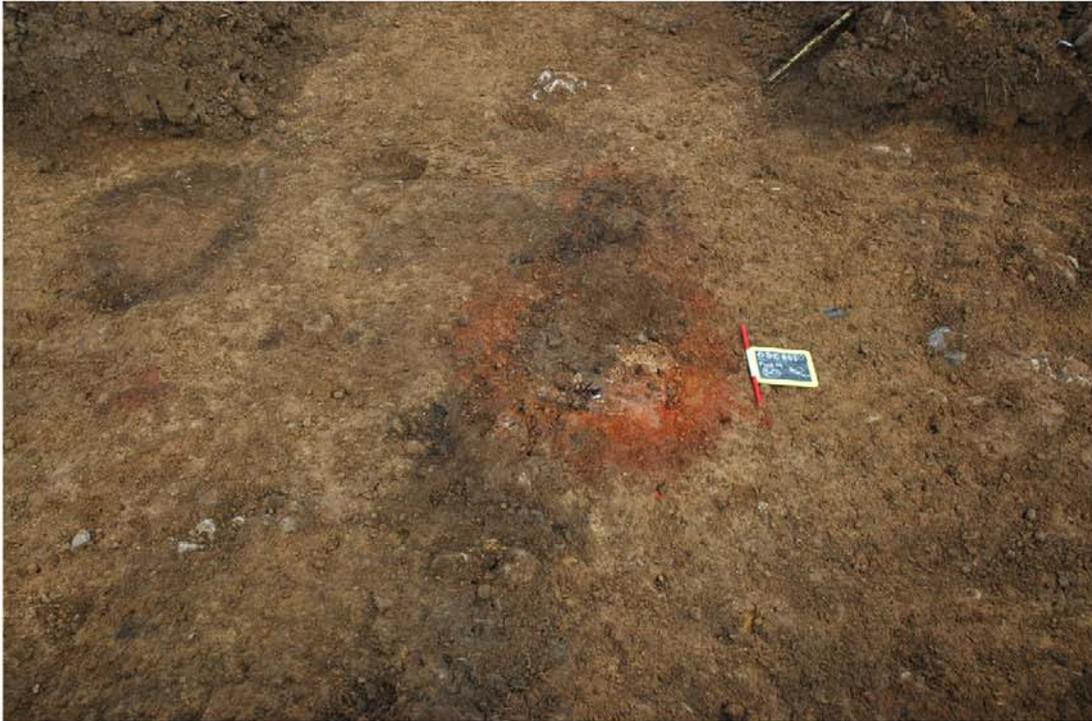
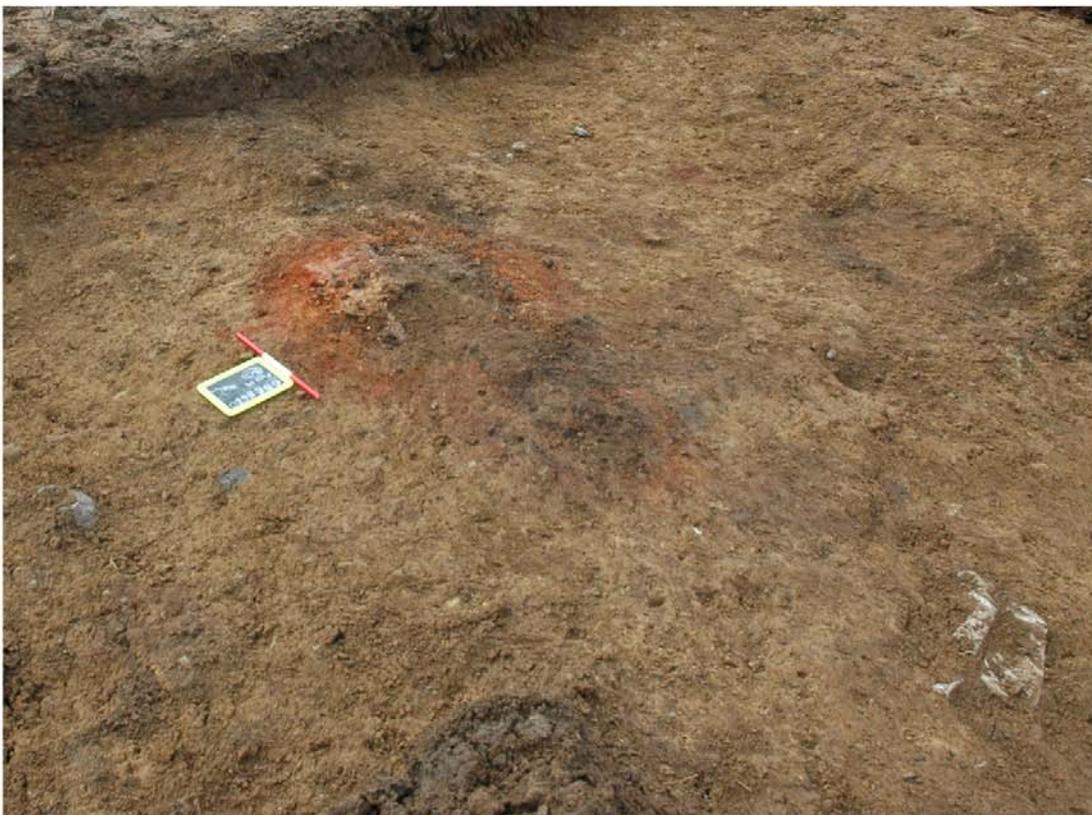
Given their proximity, it is very likely that Features 1 and 2 are contemporary.

**Plate 33: Field 19. Feature 1 (r) and Feature 2 (l). Looking north-east.
Scale 0.3m**

**Plate 34: Field 19. Feature 1 (l) and Feature 2 (r). Looking north-west.
Scale 0.3m**

Field No.	Proposed further archaeological work	Reason
1	No further work	No archaeology found
2	No further work	No archaeology found
3	No further work	No archaeology found
4	No further work	No archaeology found
5	No further work	No archaeology found
6	No further work	No archaeology found
7	No further work	Not tested but small and similar to adjacent fields
8	No further work	C18 th /19 th brick kiln
9	No further work	No archaeology found
10	No further work	No archaeology found
11	No further work	No archaeology found
12	No further work	Not tested but small and similar to adjacent fields
13	No further work	No archaeology found
14	No further work	No archaeology found
15	No further work	No archaeology found
16	No further work	No archaeology found
17	No further work	Prehistoric lithic found
18	No further work	No archaeology found
19	Excavation	Iron Age iron smelting furnace found. Features 1 and 2. Site 1
20	No further work	No archaeology found

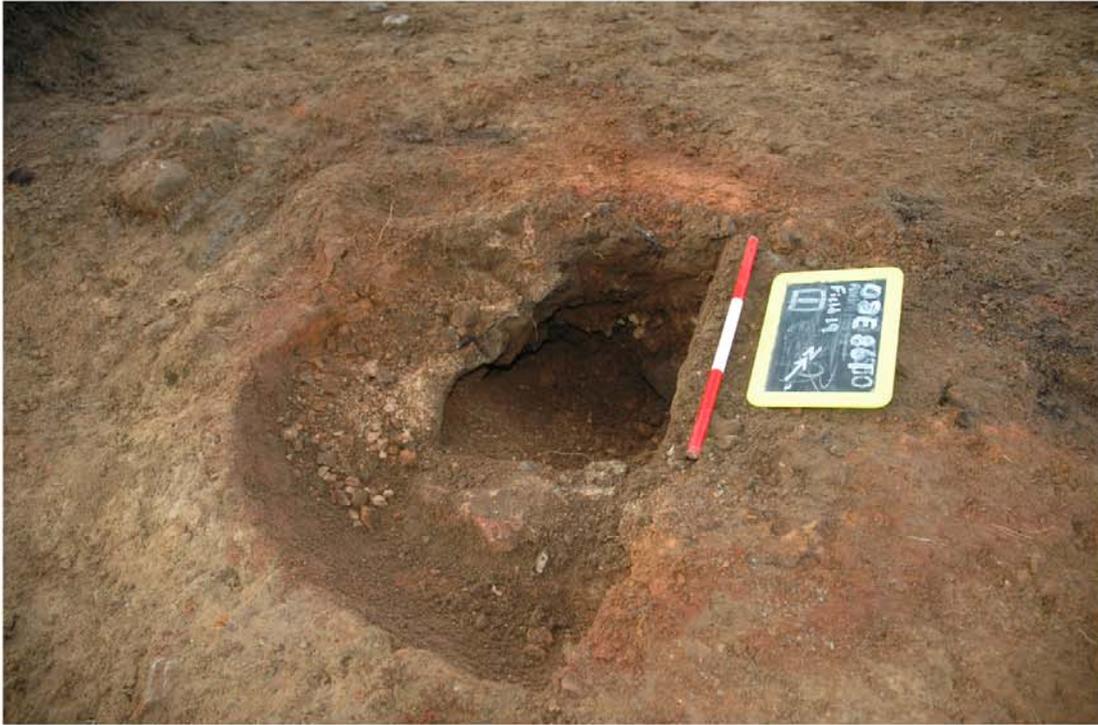
A piece of charcoal was recovered and has been submitted for radiocarbon dating. The charcoal has been identified as a *Quercus sp.* (oak) fragment weighing <1 gramme by Susan Lyons. A piece of this charcoal has been radiocarbon dated to the Iron Age (see below).

Plate 35: Field 19. Feature 1. Partially excavated. Looking north-west. Scale 0.3m

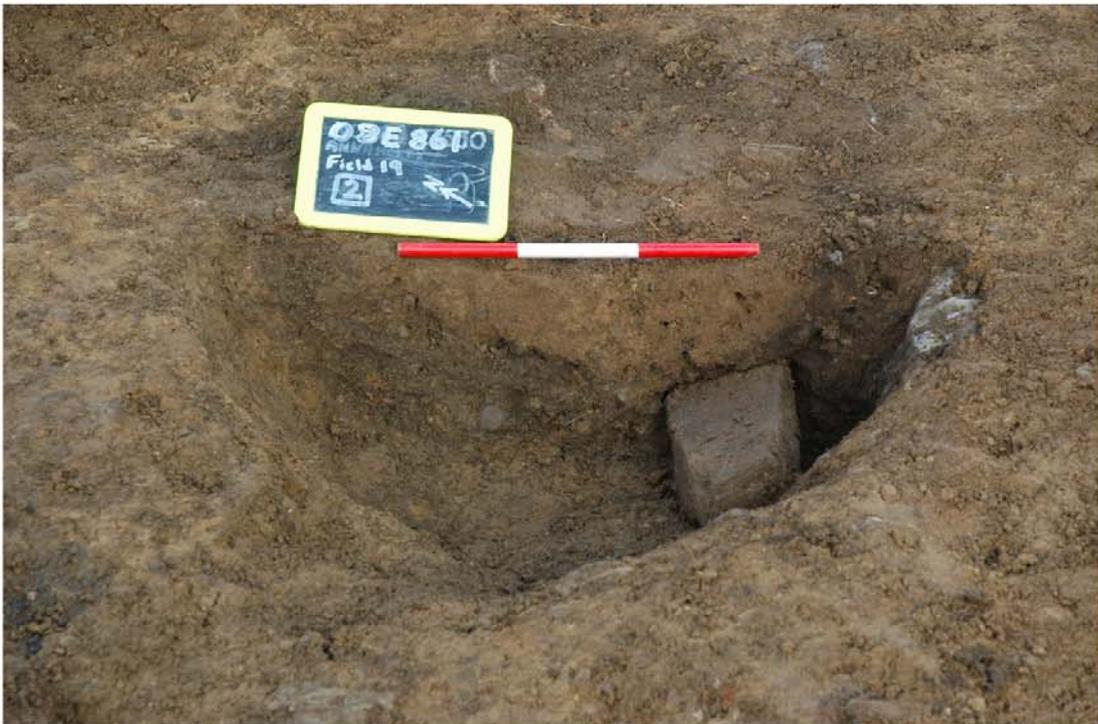
Plate 36: Field 19. Feature 2. Half sectioned. Looking north-east. Scale 0.3m

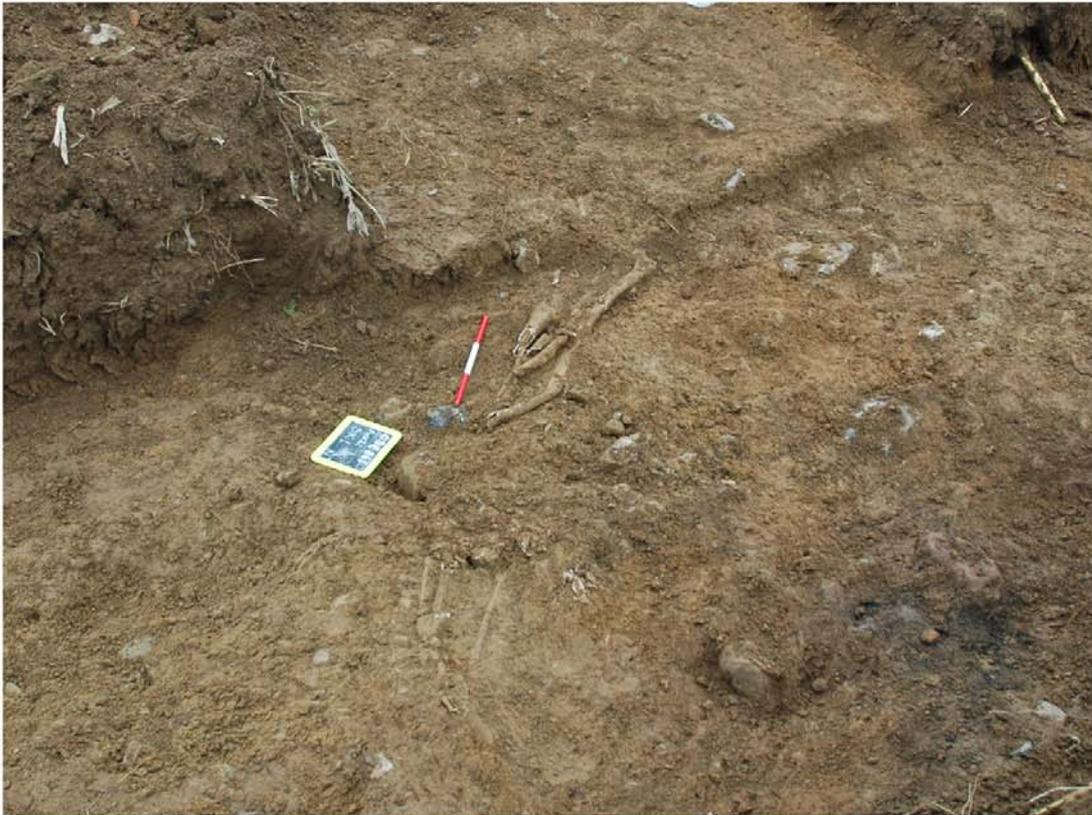
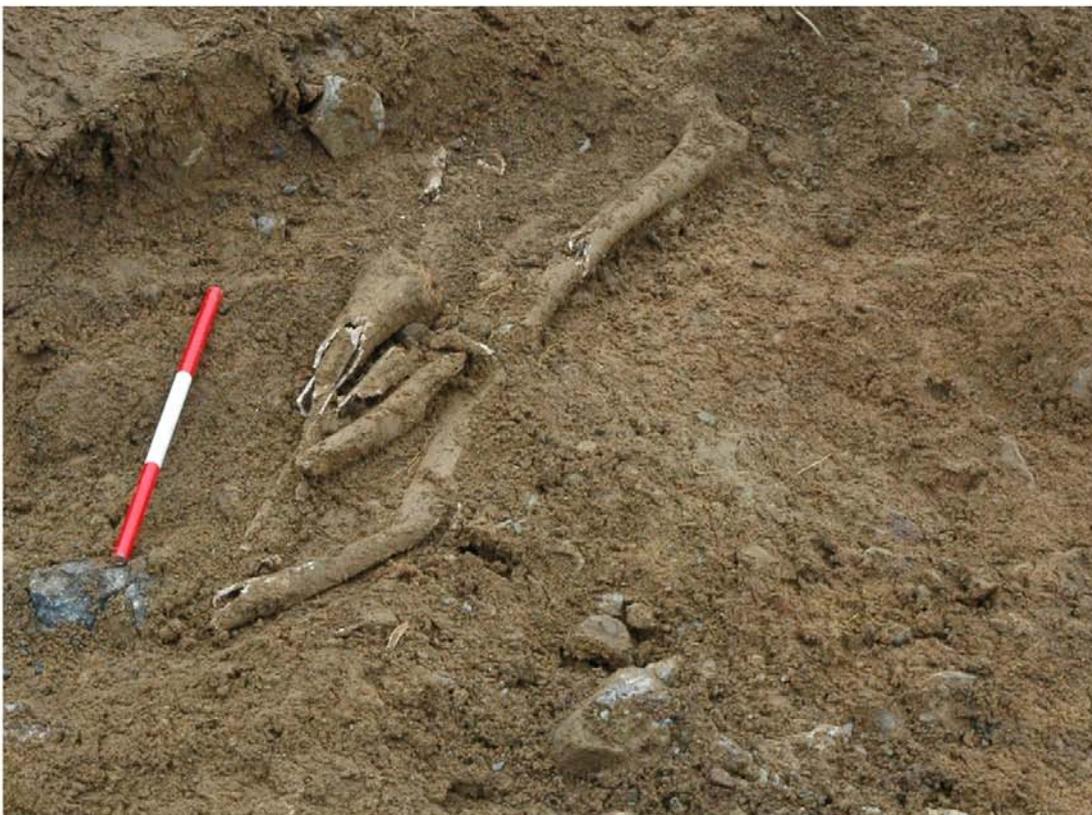
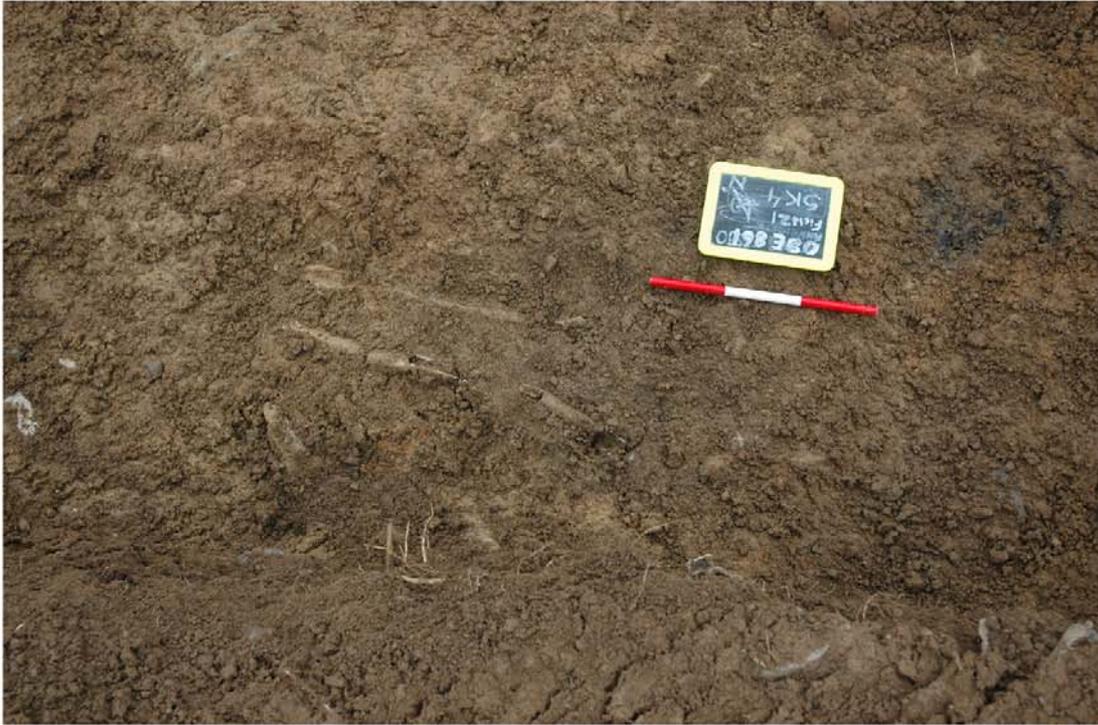
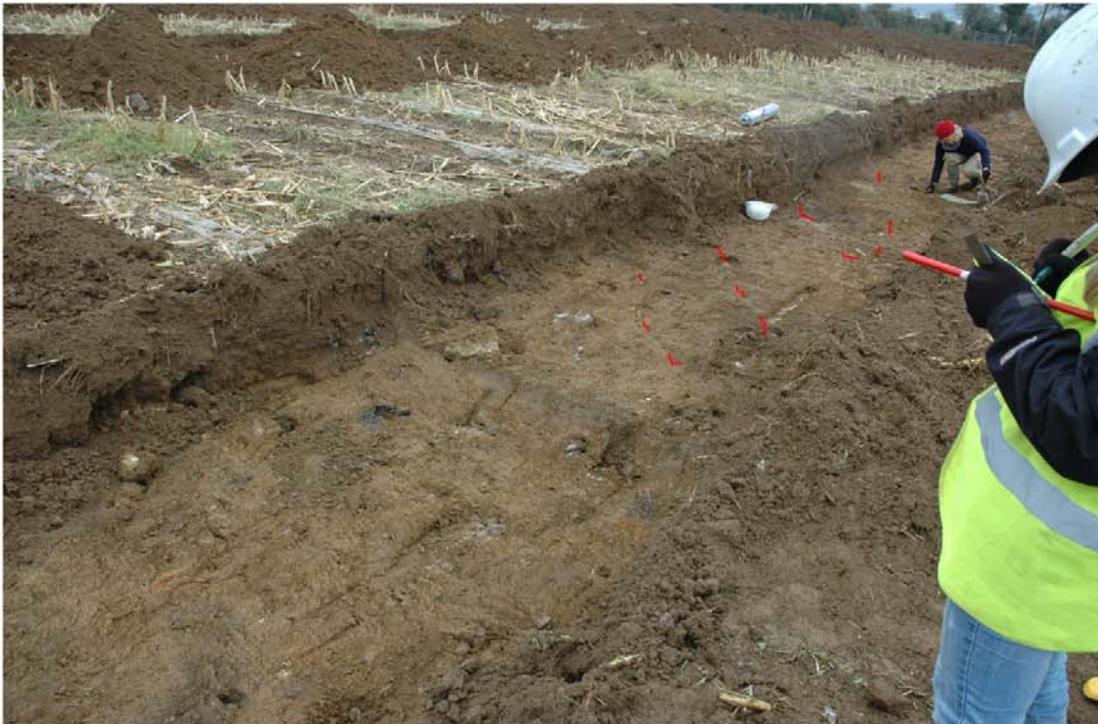
An inhumation cemetery was found on high ground in Mullagh townland centred on NGR 211550 275460 (chainage 450) (Fig. 3 and Plates 41-44). Once the graves were located, machining was undertaken very carefully in the vicinity and not all the burials were fully exposed. Extra trenching was excavated in order to define the limits of the cemetery. Approximately seven burials or grave cuts were identified. The burials are articulated and orientated from west (head) to east and this strongly suggests Christian ritual. Two pieces of iron that may be coffin nails or shroud pins were recognised but not retrieved at the testing stage. It was clear that some graves contained more than one individual and that infant and adult bones were present. A piece of a tibia and a tooth from different individuals were sampled and these have been submitted for radiocarbon dating.

One right mandibular deciduous molar. Fully formed. Minimum age for this individual is 3 years old. This tooth is usually lost around 11 years of age, however more information about the burial and where the tooth was found would be needed to give a maximum age. The tooth has been radiocarbon dated to the period between the later 15th century and the earlier 17th century (see below).

The burials had been damaged by ploughing – probably in the very recent past and lay beneath approximately 0.3m of topsoil/ploughsoil.

No evidence of an enclosing feature such as a ditch was recognised.

Plate 41: Field 21. Skeletons 1-3. Looking west. Scale 0.3m

Plate 42: Field 21. Skeletons 1-3 (detail). Looking west. Scale 0.3m

Plate 43: Field 21. Skeleton 4. Looking south. Scale 0.3m

Plate 44: Field 21. Grave cuts. Looking south-west

21	Excavation	Medieval/post-medieval inhumation cemetery and isolated pit 3 found. Sites 2 and 3
22	No further work	Early modern Isolated feature 4 found
23	No further work	No archaeology found
24	No further work	No archaeology found
25	No further work	No archaeology found
26	Excavation	3 x burnt stone deposits found ?Bronze Age Site 4

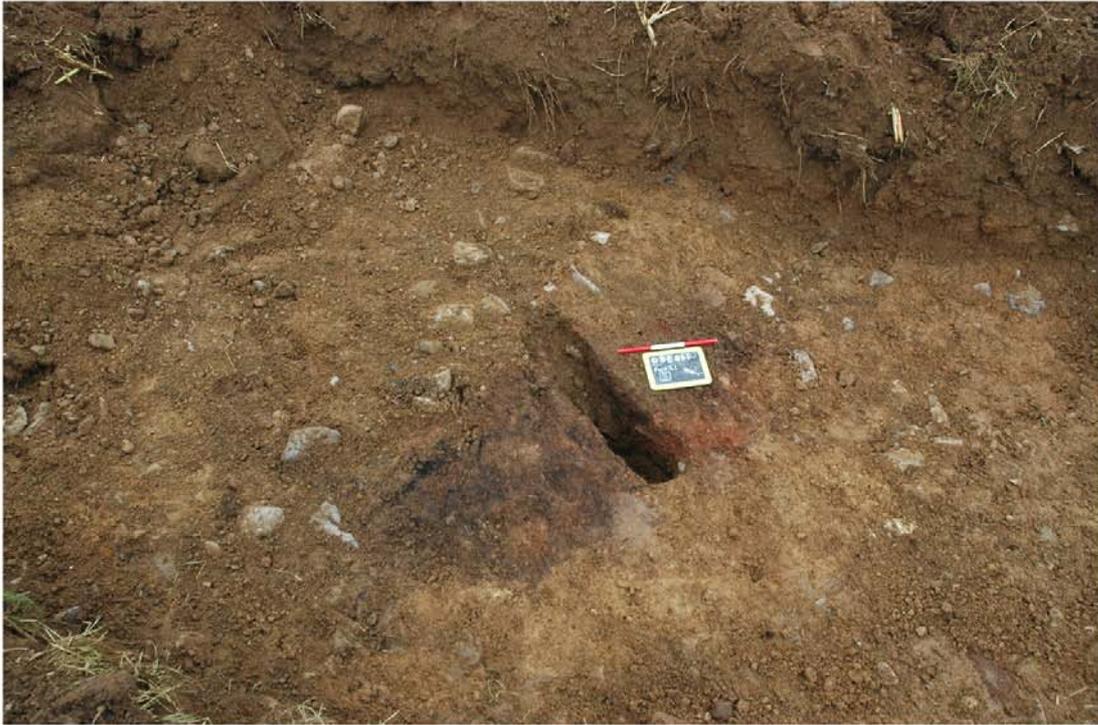
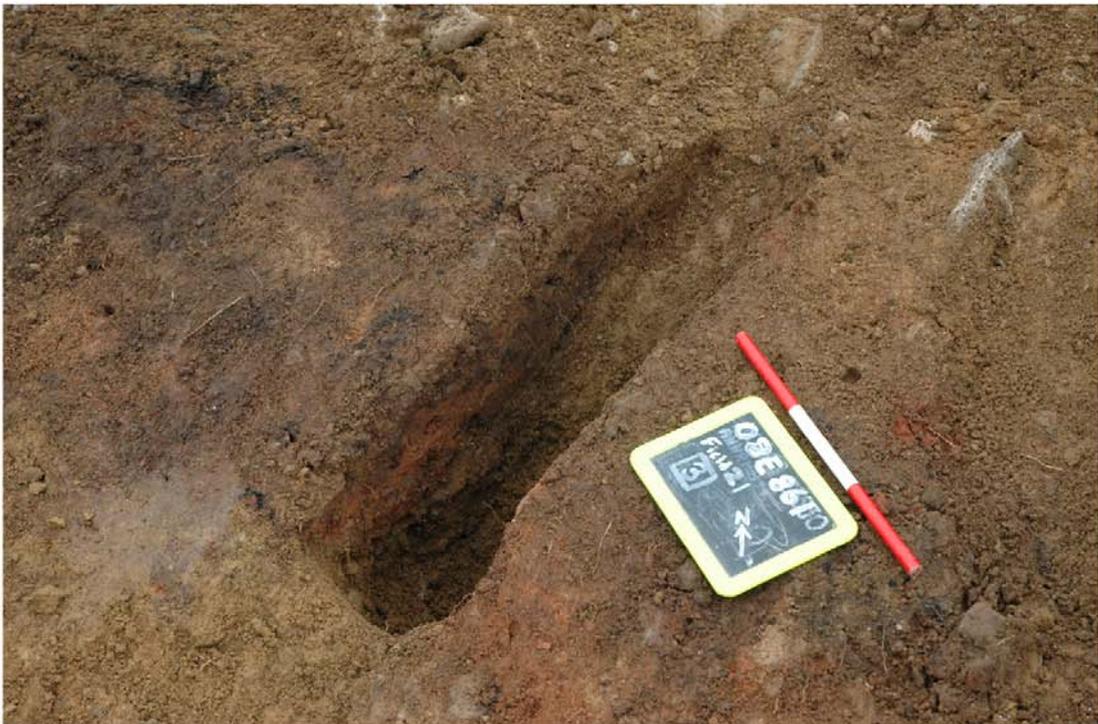
A seemingly discrete feature (3) was found in the townland of Mullagh at NGR 211576 275381 (chainage 380) (Figs 3, 5 and 7 and Plates 45 and 46) on a south-facing incline. Feature 3 is oval in plan, measures 0.58m (north-west to south-east) by 0.28m and is 0.16m deep. A narrow slot was excavated across the feature. The feature fill 53 is a firm, mid orangish brown silty clay with occasional gravel inclusions. Frequent red and black oxidisation and charcoal deposits are present.

Plate 45: Field 21. Feature 3. Looking north-east. Scale 0.3m

Plate 46: Field 21. Feature 3 (detail). Looking north. Scale 0.3m

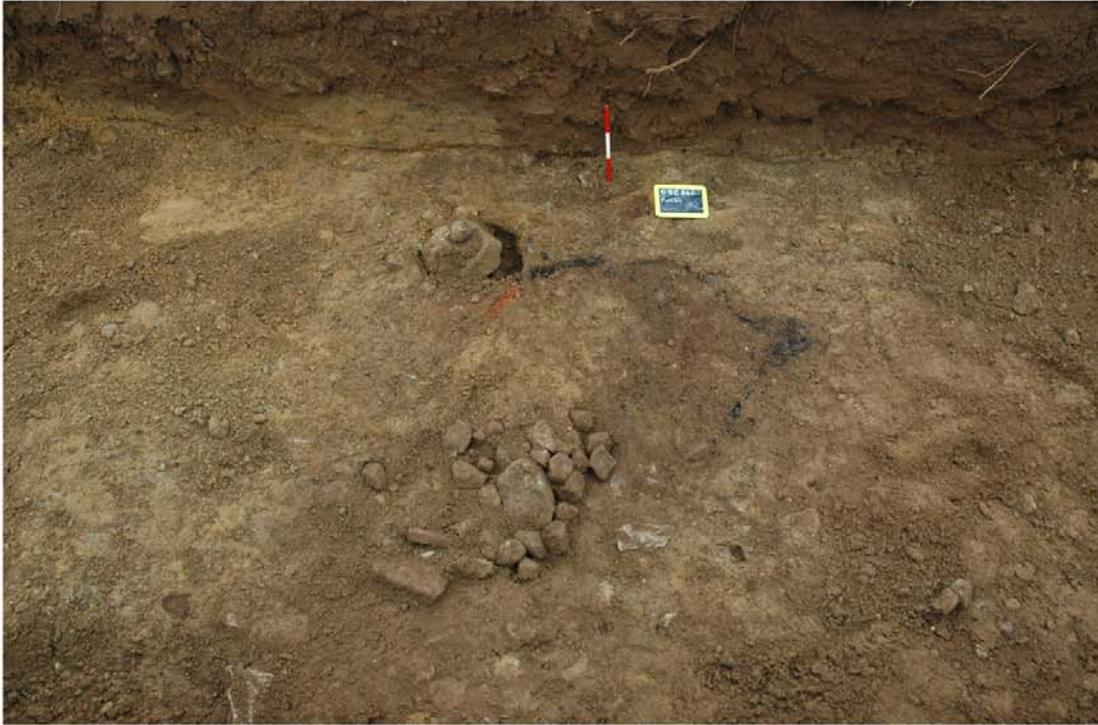
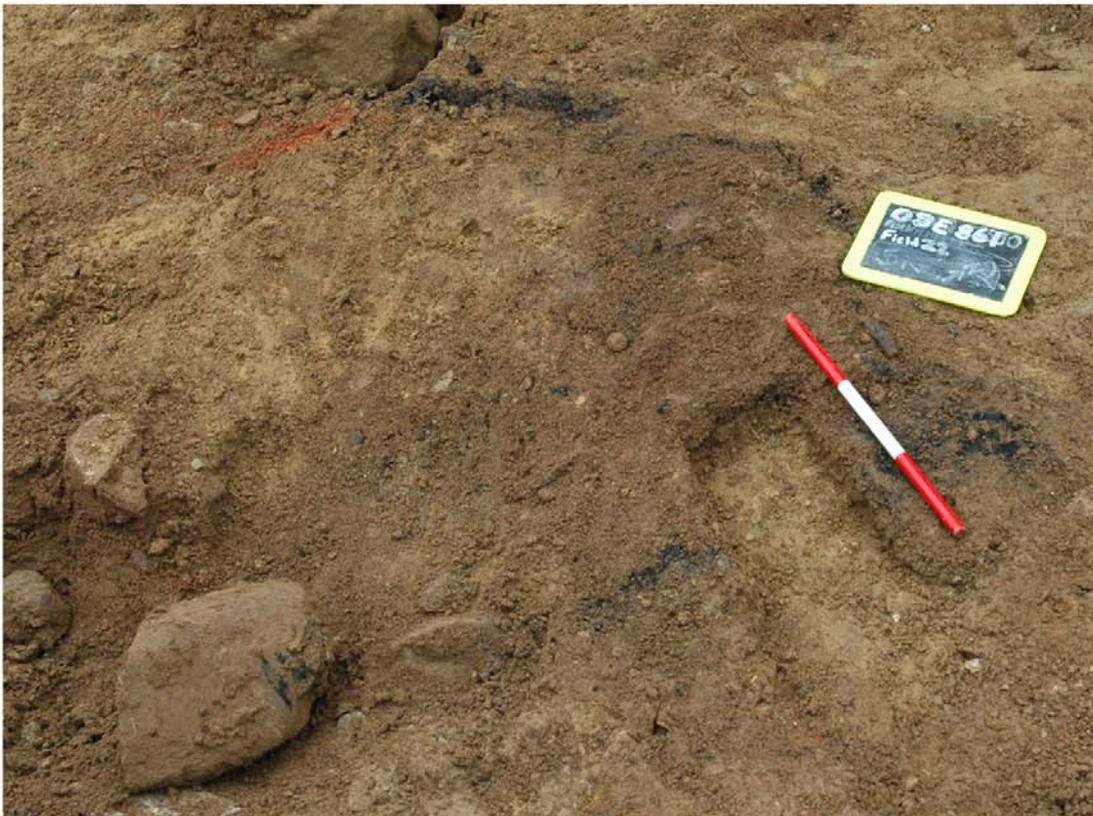
A second isolated feature (4) was found in Mullagh townland at NGR 211558 275292 (chainage 290) (Fig. 3 and 4 and Plates 49 and 50). Feature 4 has been truncated by a modern stone-filled drain at the south but was very probably circular and has a diameter of 0.7-0.8m. The feature fill 54 was a loose

mixed hue silty clay with frequent charcoal inclusions. Oxidised clay suggests *in situ* burning. A small slot excavated into Feature 4 established a depth of 0.03m.

Plate 49: Field 22. Feature 4. Looking west. Scale 0.3m

Plate 50: Field 22. Feature 4 (detail). Looking west. Scale 0.3m

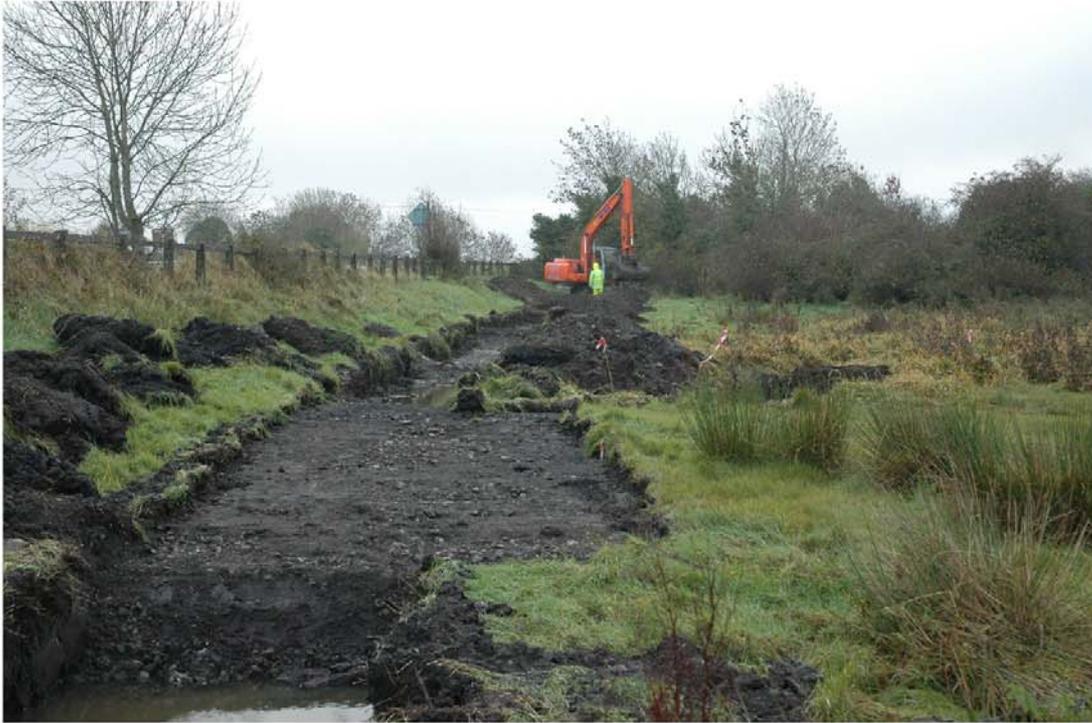
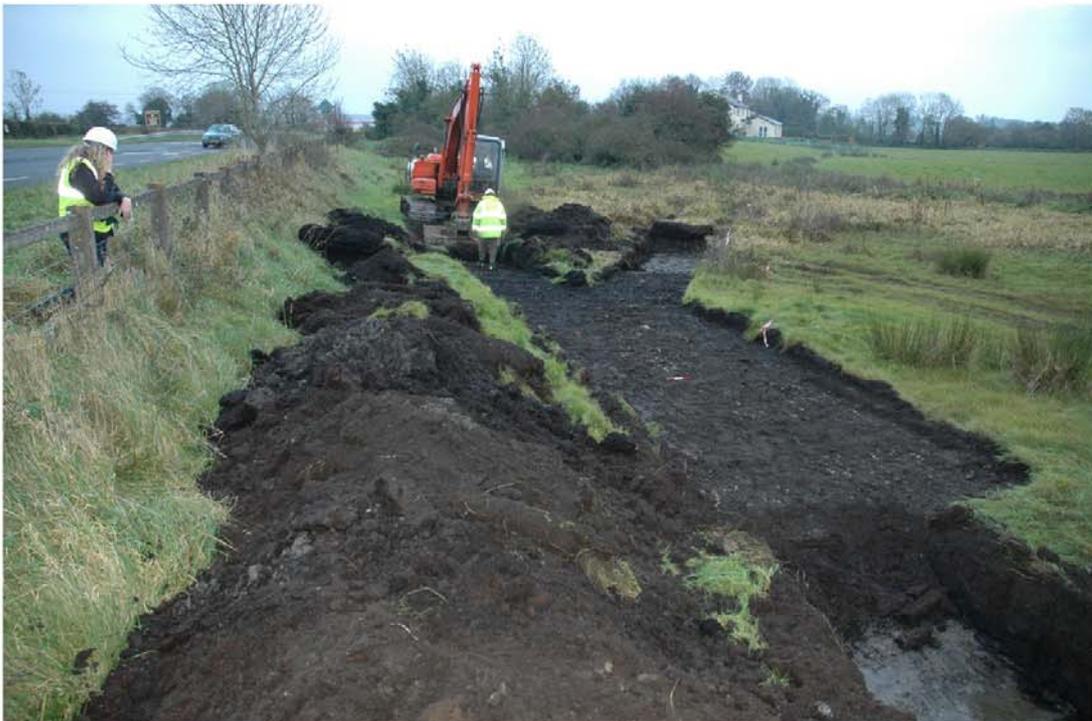
Within the lands set aside for the road-take, burnt stone deposit A measures 14m (east to west) by 5m (north to south) and is lenticular, between 0.1m and 0.4m thick. The monument is composed of fire-reddened limestone and sandstone pieces that are typically in the size range of 0.04-0.05m. A probable timber-lined trough was found a few metres to the east. Horizontal timbers were observed in a rectangular cut that measures 1m (east to west) by 0.5m (north to south – maximum extent visible in trench). The trench filled with water before the feature could be examined in more detail.

These monuments are not of the same magnitude of scale as the larger, but similarly composed, *fulachtaí fia*. Burnt stone deposits lack the formal crescent shape of the *fulacht fia* but are found in similar watery locations and are often associated with troughs or pits. Rather than being thought of as ‘ploughed out’ or levelled *fulachtaí fia*, burnt stone deposits are becoming increasingly recognised as distinct monuments in their own right. Burnt stone deposits suggest similar, but less intense or less long lasting, activity than that currently postulated for the *fulacht fia* or burnt mound.

Plate 59: Field 26. Burnt stone deposit A. Looking east

Plate 60: Field 26. Burnt stone deposit A. Looking east. Scale 0.3m

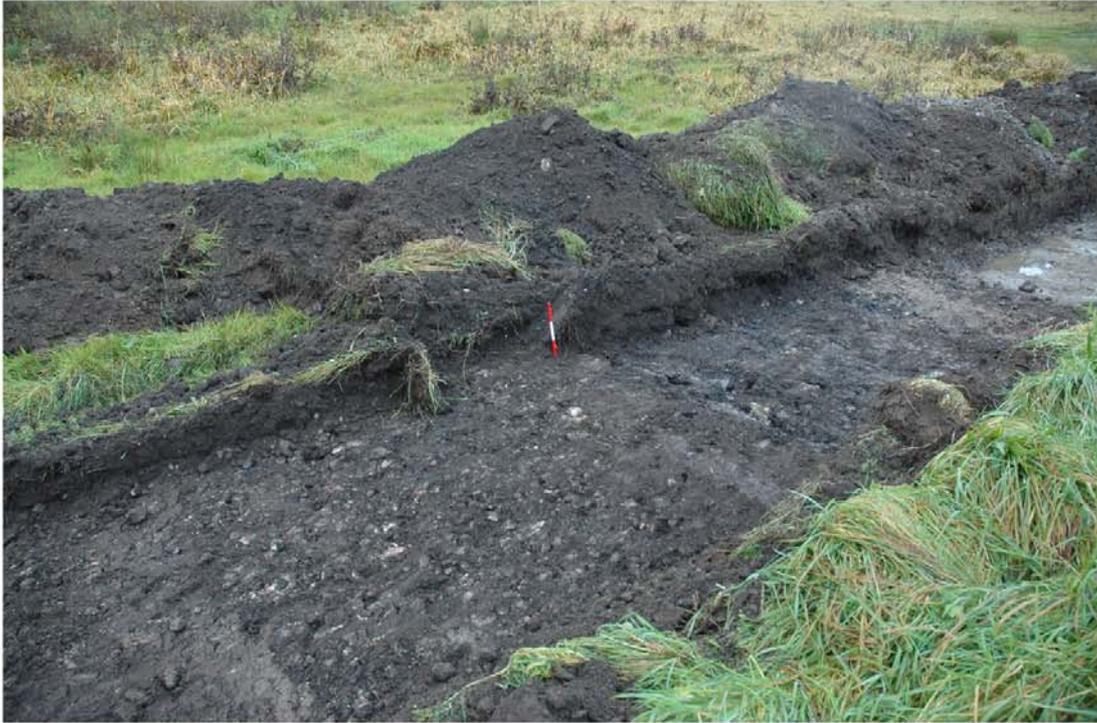
Plate 61: Field 26. Burnt stone deposit B. Looking south-west. Scale 0.3m

Burnt stone deposit B measures 4.3m (east to west) and is likely to be approximately 8m from north to south. The composition of burnt stone deposit B is identical to A.

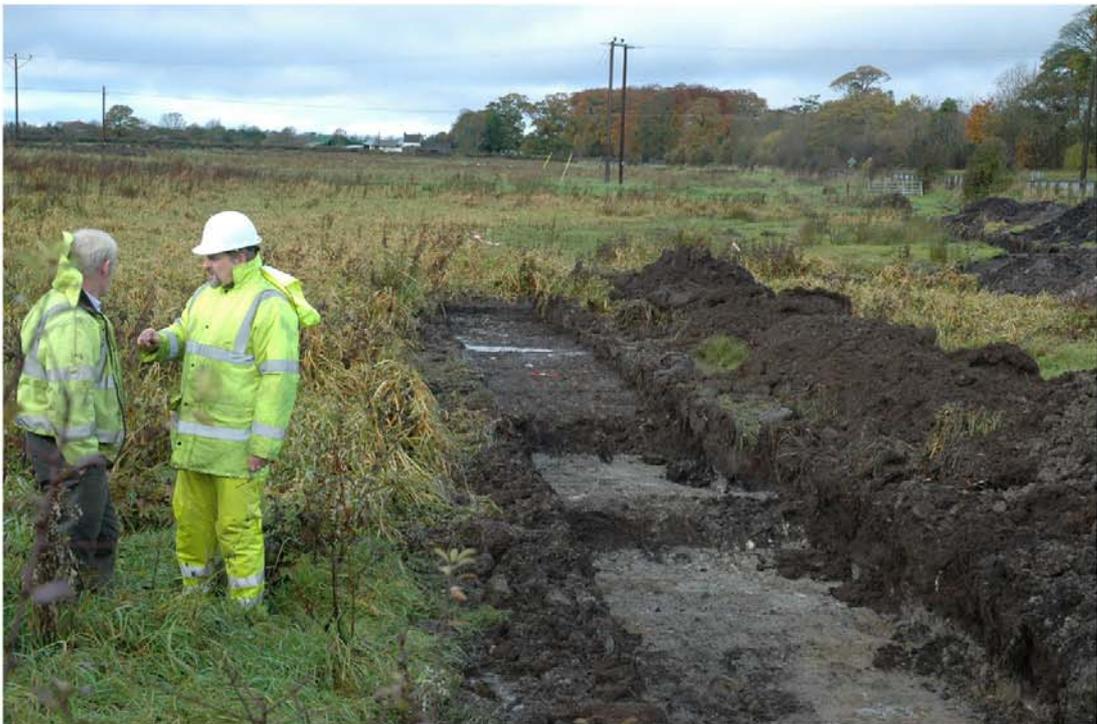
Plate 62: Field 26. Burnt stone deposit C. Looking west. Scale 0.3m

Burnt stone deposit C measures 12m (east to west and extends outside the road-take to the west) by approximately 8m and is likely to be 0.1 m to 0.4m thick. The stones in this deposit were larger and in the size range of 0.15m.
